### The Parry Snappy

### The "Wayfarer Sand Nappy"

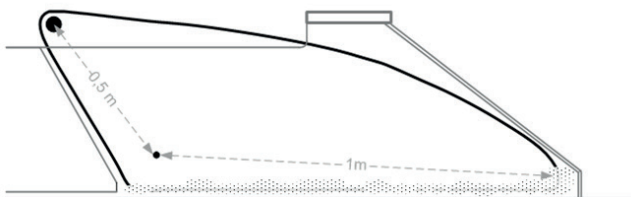
The diagram below shows the reason for the problem; a Pebble of a diameter 3 to 10 mm can fit in the gap between the centre board case and the centre board. Any movement digs the pebble into the wood and cements the problem. There is a mechanical disadvantage to moving the centre board because of the leverages involved (see diagram).

Side view of Centreboard with pebbles or sand in the bottom of the centreboard cage

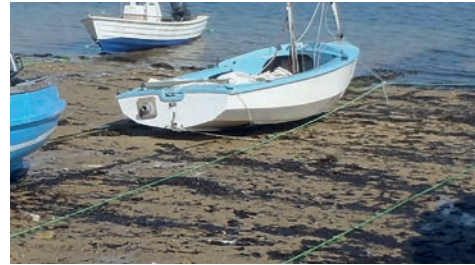
So what to do? The solution, garnered from the days of ancient sailing ships, is to apply a fothered sail underneath the boat covering the centre board slot.

The ideal solution (for us) was to purchase an 8 x 4 plastic tarpaulin, with brass eyelets and attach elastic bungee and hooks at the four corners. The Wayfarer nappy is then tightly attached underneath the hull and secured to appropriate shrouds, bridle etc.

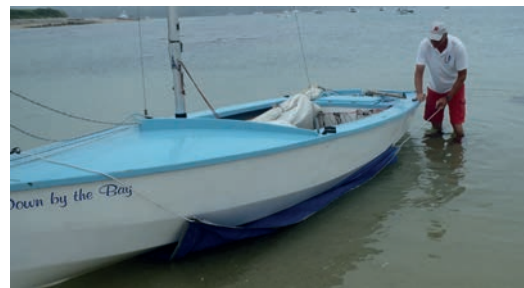
Thus applied, the tarpaulin creates the perfect preventative barrier to feldspar ingress, and centre board jams become a thing of the past.
